Problems Encountered During the Recertification of the GLORY Solar Array Dual Axis Gimbal Drive Actuators

ABSTRACT

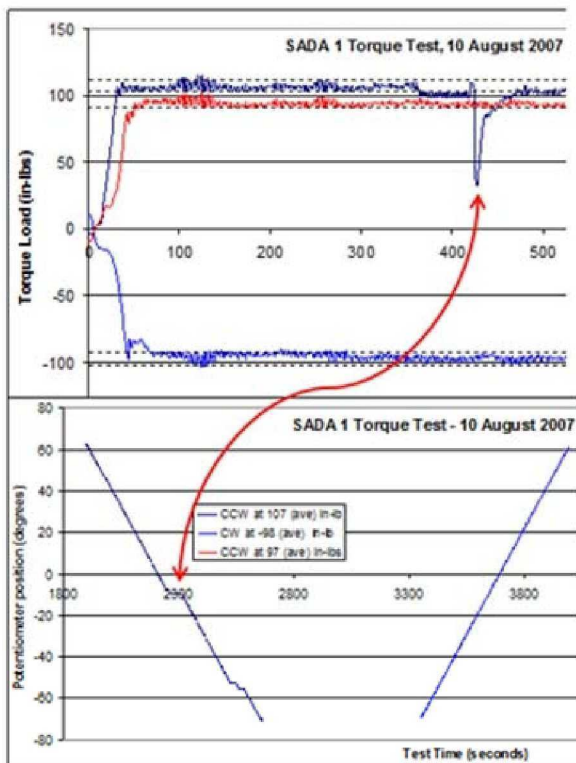
Figure 4 Torque Test Data

Torque capability in the 150 in-lb to 190 in-lb (16.9 N-m to 21.5 N-m) range was produced prior to shipment but, as demonstrated by the plots in Fig. 4, there was either 30% degradation in torque or a serious flaw existed in the test apparatus. At least two days were spent checking the calibration of the torque test setup. The final test results for both SADAs are shown in Tab. 2. In this table, "N/A" indicates the configuration could not be tested without disassembly.

loss changes on the order of 30%. This mysterious torque loss was very perplexing. Moog was contacted to validate our torque testing approach, and they did validate it. Despite test setup confirmation indicating our torque measurement approach was not flawed, the sentiment at the time was that something was amiss with the setup and that the SADAs were, most likely, acceptable. A large contributor to this sentiment was the fact that the threshold voltage measurements were very reassuring. Nevertheless, NASA and Orbital agreed to follow the logic flow of our recertification decision tree and send the units back to Moog for a set of confirmation tests. At the time, it was assumed that some detail of the test setup or apparatus was flawed and that the inconsistency between the threshold test data and the torque test data would be resolved when Moog retested the actuators using the original test equipment.

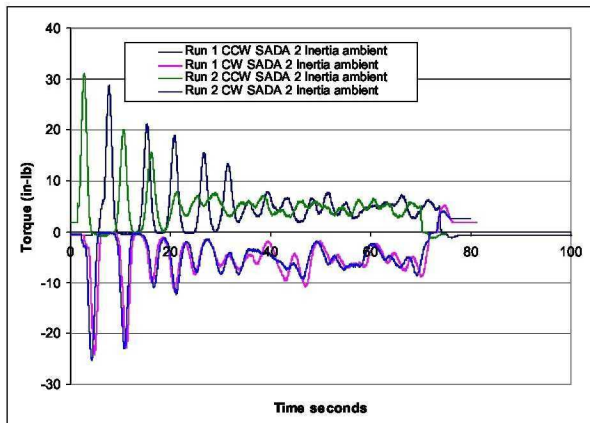
Figure 7 SADA 2 Inertia Test Record

spokes to adjust inertia. While the test increased confidence that the inertia can be started at 2°/second the amount of backlash in the test system precluded complete certainty of that conclusion. The majority of backlash was attributed to the test setup gear reducer and not in the SADA itself. The presence of backlash is non-conservative with respect to starting the inertia because more time is available for the momentum to increase which means the torque required from the actuator can be lower.

To achieve a more conservative, test the actuator speed was increased to 4°/second and then 6°/second. In all cases the inertia was started without any lost steps. Additional test were conducted with the backlash

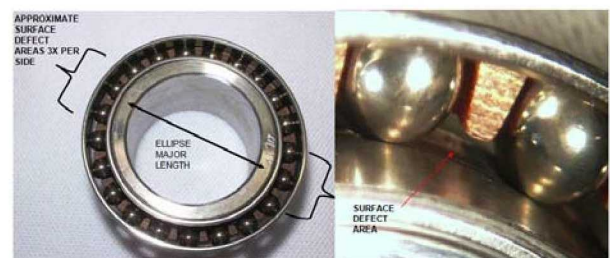
Figure 9 Harmonic Drive Wave Generator Bearing with Defect Areas

- The alpha drive showed no degradation from 1999.
- The beta drive showed the 30% to 40% degradation measured by Orbital.
- The SADA 1 motor stator housing was removed allowing the rotor/harmonic wave generator to remain installed. Moog observed that rotor rotation was 'lumpy' with repetitive cyclic torque peaks of approximately 6.5 inch-ounces (45.9 mN-m) versus the Moog

requirement for new hardware of 2 inch-ounces (14 mN-m).

- There remained a good quantity of grease/oil slurry present in the wave generator bearing.
- The amber colored lubricant inside the harmonic drive wave generator bearing was somewhat darker in places than the shade for new lubricant (50% Pennzane oil & 50% Pennzane grease).
- The cleaned wave generator bearing races had small patches of discoloration with a grainy appearance from either embedded material or a divot. These are shown in Fig. 9. Three such patches on each side were located on the inner race at the major diameter areas and coincided with the spacing of the balls. The remaining portions of the races were clean and smooth. An attempt was made to mechanically remove the discoloration using a pointed plastic stick but this was not successful.

SADA 2 was returned to Moog and retested on 1/30/2008. The beta drive showed 20% to 30% output torque degradation. The beta actuator was disassembled and showed the same discolored areas shown in Fig. 9, but not quite as prominently. Prior to disassembly the actuators were subjected to both threshold voltage and torque testing for comparison with the results recorded earlier by Orbital. These results also placed in question the validity of using threshold voltage testing as a conclusive verification that all is well with an actuator.

At this point the flow path led NASA, Orbital and Moog to the decision to disassemble the wave generator bearings from the beta actuators and subject the races and balls to laboratory testing. After two separate investigative sessions at Seal Laboratories, Moog's assessment was that the discolored areas were, in fact, pitted areas most likely due to stress corrosion. Fig. 10 shows a visual summary of the typical findings. Except for a very minor amount of discoloration observed on the alpha actuator of S/N 1, the alpha

Based on the aforementioned findings, Orbital revised the Moog service agreement to include complete replacement of all harmonic drive bearings in both SADAs 1 & 2. While not contributing to the degradation the cotton phenolic wave generator bearing retainers were vacuum impregnated using an extended time of 3 days as recommended by the NASA

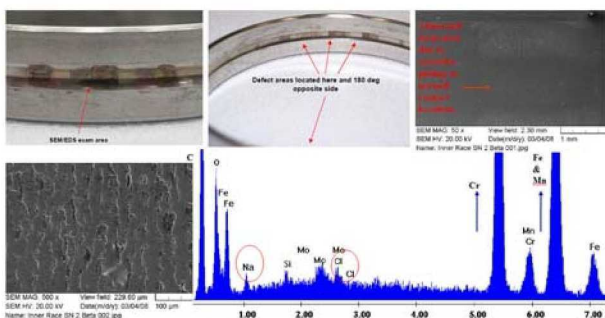
Figure 10 Laboratory Investigation Findings

Moog determined that the harmonic drive supplier had used a chlorinated solvent as part of the cleaning process. This practice has long since been prohibited but at the time the VCL SADA components were manufactured the process was still in use. It is thought that some small amount of this solvent had not been fully washed away. This in combination with the presence of sodium in the grease thickener provided the constituents for a salt solution only awaiting the arrival of small amounts of water vapor, the presence of oxygen, and, lastly, the availability of lots of time for the corrosion process to attack the bearing surfaces under most stress. The elliptical wave generator plug provided the stress. The evidence for the presence of chlorine and sodium is shown in the electron dispersion spectrographic (EDS) analysis portion of Fig. 10. Until 2004, the SADAs were stored with the VCL bus bagged and with an N2 cover gas but it was never confirmed that the cover gas had not dissipated, that the bag was entirely leak tight, or that trace amounts of moisture did not exist in the purge gas. In addition, after 2004, the SADAs were exposed to the atmosphere as they were required for integration and test purposes. There remains the mystery as to why the alpha actuators were not nearly as degraded as the beta actuators. Nevertheless, the root cause was concluded to be stress corrosion due to the incomplete cleaning of the harmonic drive components leading to the presence of small amounts of chlorine, sodium, water vapor, oxygen, and lots and lots of time.
